Ririe Dam Release Test Assessment

Steven F. Daly, Meredith Carr, Stephen Hall, and
Jeremy Giovando

Final Report

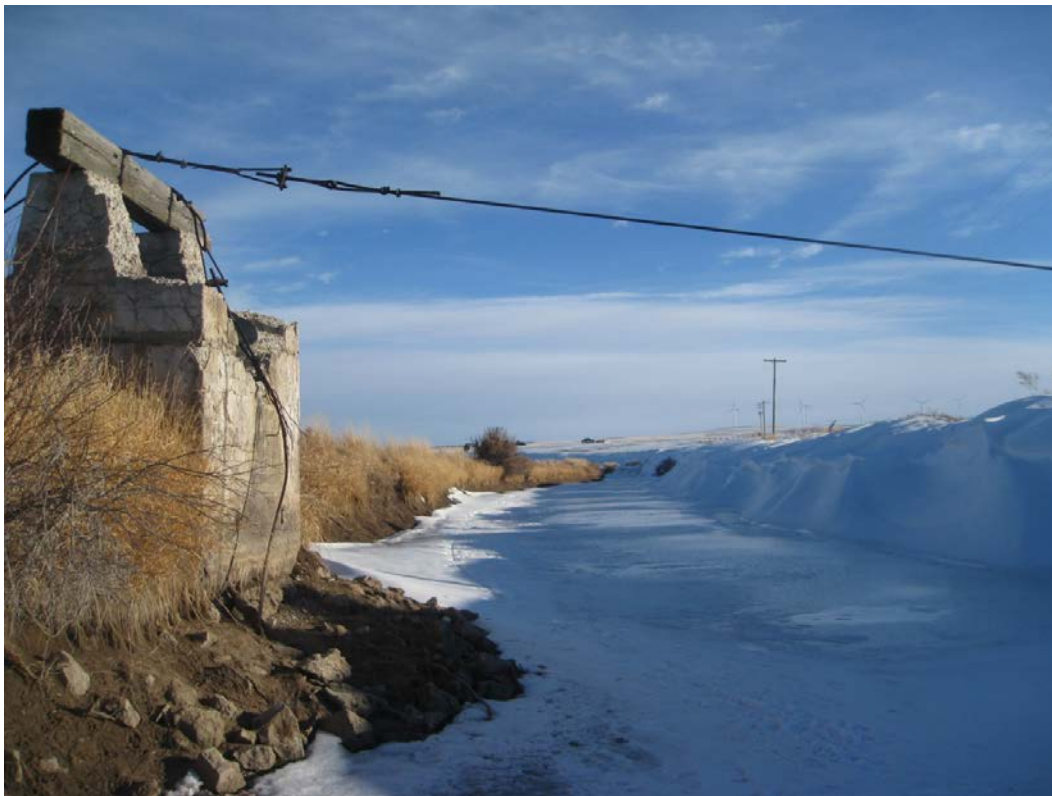
As a result of the flow in the canyon section of the Willow Creek natural channel, an ice cover was in place on Willow Creek starting about 0.25 miles upstream of the 115th St. Bridge and extending an unknown distance upstream. Holes drilled through the ice cover for ice fishing showed an ice thickness of 16 in. near the downstream end of the ice cover. A survey done on foot was conducted over a distance of approximately 1 mile upstream of the 115th St. Bridge (Fig. 7). Willow Creek ice covered over this entire 1-mile reach. Approximately 0.5 upstream of the 115th St. Bridge were the remains of a snow avalanche. The avalanche resulted from snow accumulation on a 50 to 75 ft bluff on the southern bank of Willow Creek. The avalanche appeared to have broken through the channel ice cover and filled approximately half the channel. The upstream extent of the ice cover was not determined, although an ice cover was observed approximately 0.25 miles downstream of Ririe Dam. No ice cover was observed downstream of the 115th St. Bridge.

Figure 7. Ice cover in place upstream of 115th St. Bridge prior to release.

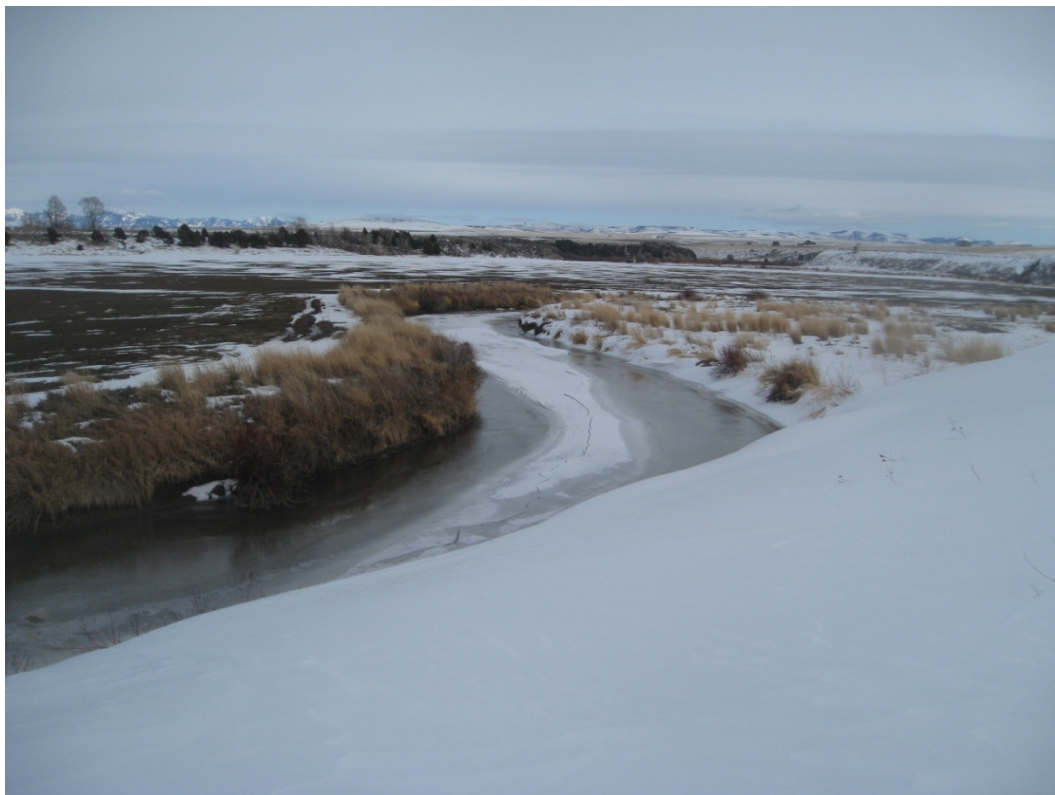
As described above, an ice cover was in place in the canyon section of the Willow Creek natural channel prior to the Release Test. The reach is located downstream of Ririe Dam and upstream of the 115th St. Bridge. When the IRW passed through this section, it caused the ice cover to fracture as the ice along the channel centerline was lifted and the ice at the banks remained frozen in place. The portion of the ice cover nearest to the banks became submerged while the middle third remained above water (Fig. 34). In general, a single longitudinal crack that ran down the center of the channel ice cover fractured the ice cover. At wider locations, two longitudinal cracks were observed, each spaced about one quarter to one third of the channel width from the channel banks. When the melt-out front reached this ice, the ice generally melted in place, although the front transported some small percentage of the ice cover downstream.

Figure 34. Ice cover upstream of the 115th St. Bridge after passage of the IRW. Note portions near banks flooded and central longitudinal crack.

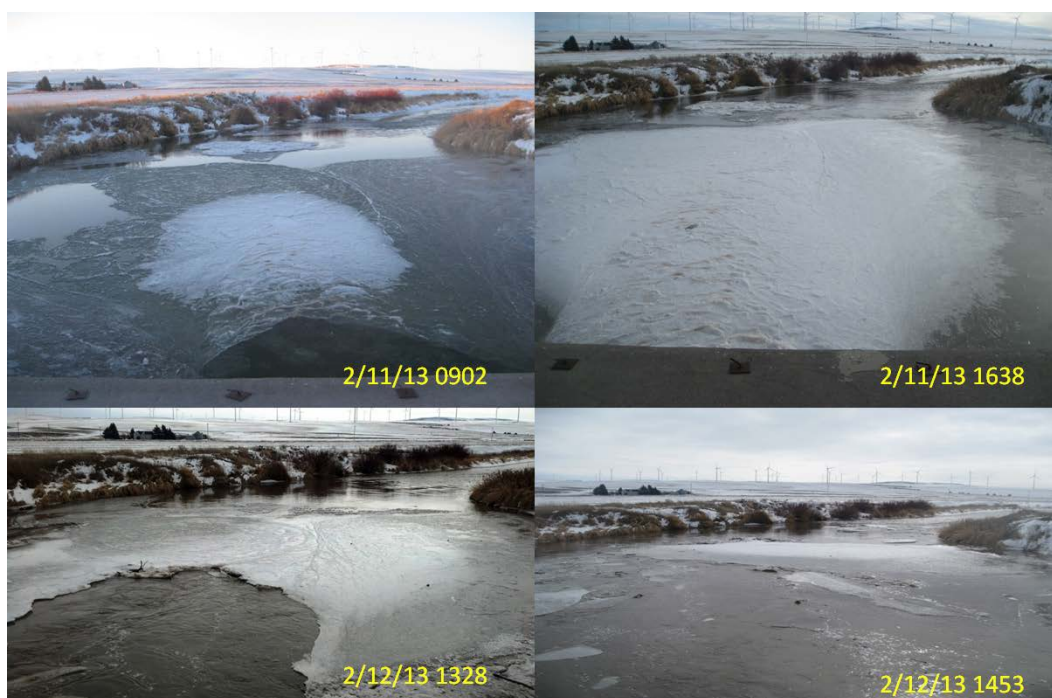
A large depression covering the width of the Willow Creek channel and having strong downstream control existed in this location. This reduced the flow velocity in this reach and provided a location where slush ice could accumulate. A hanging dam-type ice formation formed and grew at this location. When the melt-out front reached this location, the hanging dam melted in place although the front transported a small percentage of the ice cover downstream. Figure 35 displays the steps in the evolution of the floating ice at this location. This ice cover did cause the upstream water levels to rise but did not produce any out of bank flooding.

Figure 35. Evolution of the hanging ice dam immediately downstream of the Ferguson Bridge.

- Monitor release wave propagation.
- With set alarm levels, continuously monitor water level upstream of the siphon.
- Periodically monitor ice conditions at the check dam, Ferguson Bridge, Snake River, and other locations as required
- Note and record the location and time of all snow and ice blockages that significantly increase the upstream stage.

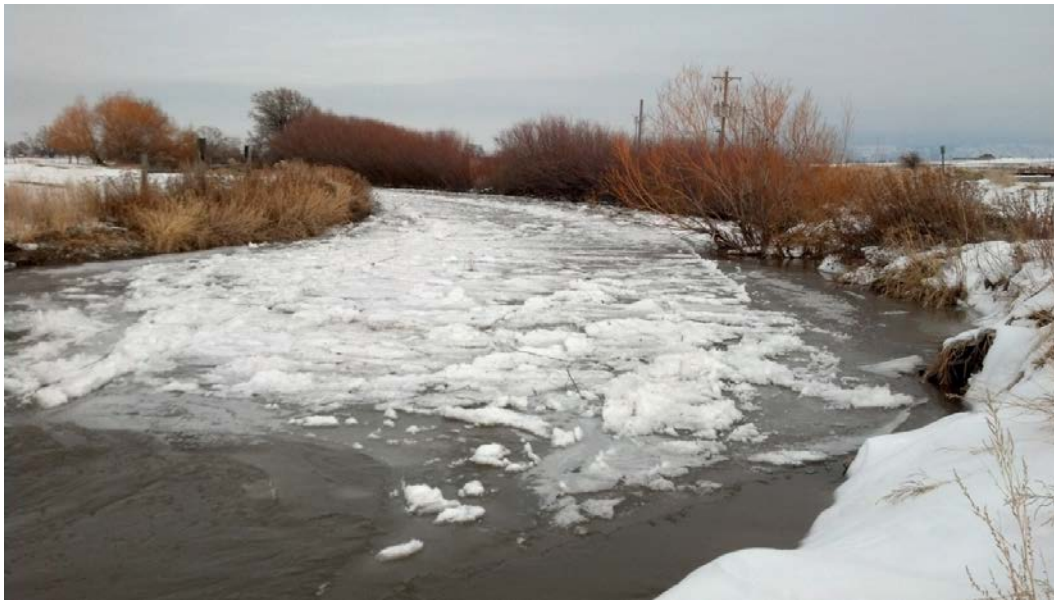
A rock check dam extends across the entire width of Willow Creek about 0.4 miles upstream of the Bifurcation. This check dam raises the upstream water level about 3 ft. Floating slush ice accumulated upstream of the check dam, and accumulation extended upstream about 0.25 miles (Fig. 36). This ice melted in place when the melt-out front reached this location.

Figure 36. Ice cover in place upstream of the check dam (looking upstream).

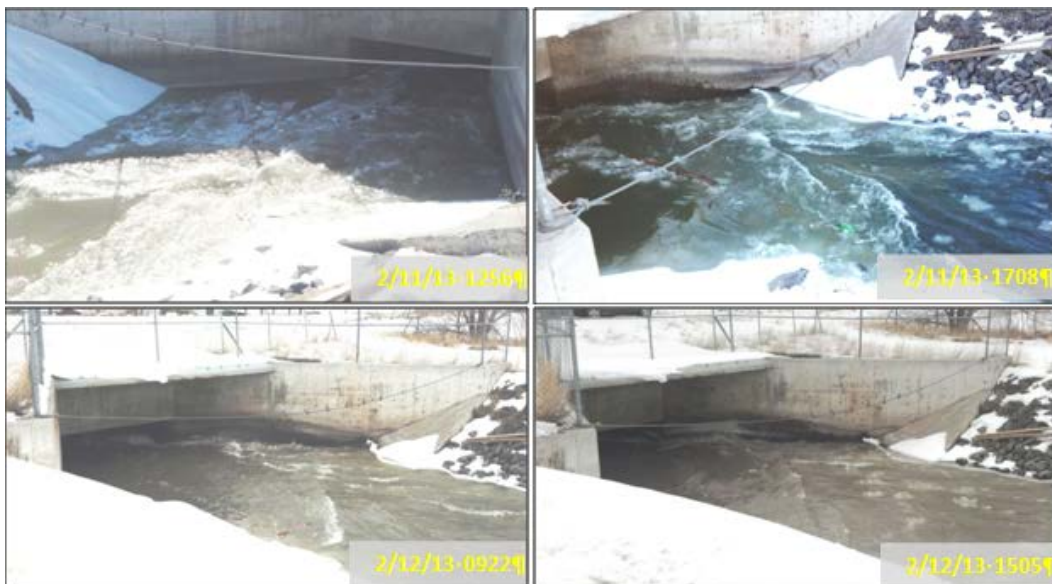
Slush ice accumulated at the siphon when the IRW first inundated the siphon passage (Fig. 37). No ice was observed to exit the siphon for approximately 10 to 15 min after the IRW reached this location. After this time, slush ice appeared to transit the siphon without difficulty and not to accumulate further.

Figure 37. Ice upstream of the siphon.

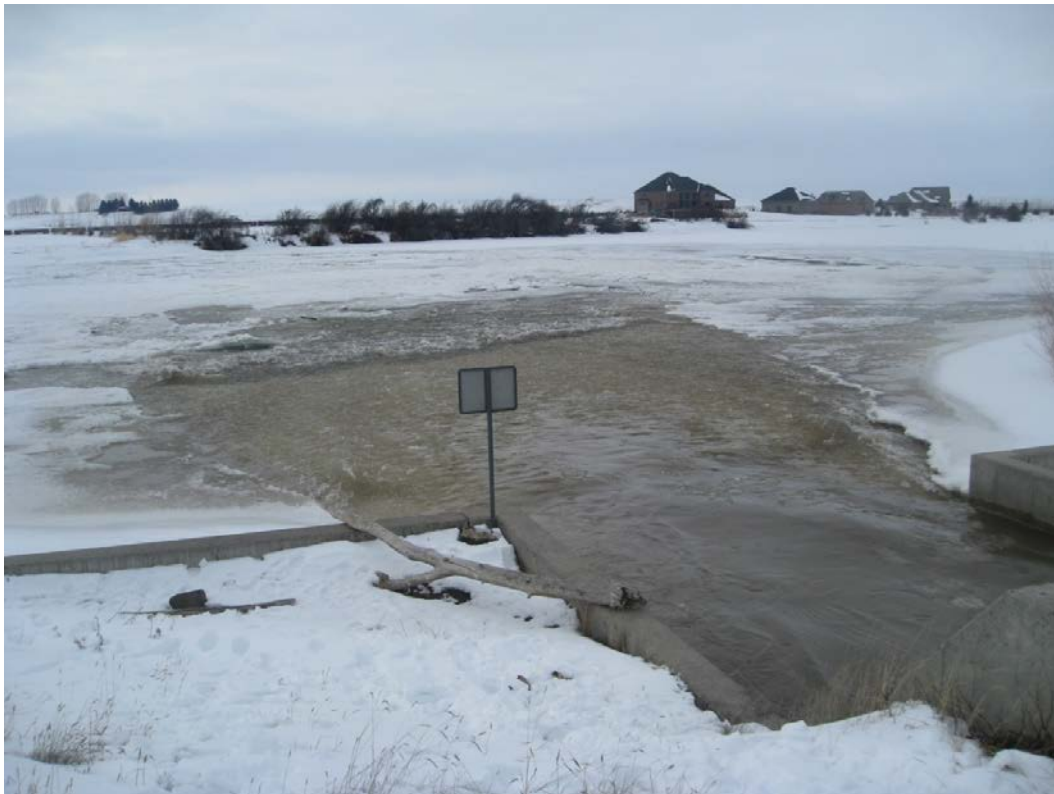
Immediately after the arrival of the IRW, a large snow drift located immediately downstream of the weir crest located at the downstream end of Willow Creek impeded the passage of water out of the Willow Creek Out-flow Channel into the Snake River. This snow drift took almost an hour to erode away even though the flow dropped from the weir crest directly onto the drift at high velocity. It is likely that while the drift was in place, it increased upstream water levels.

At the time of the Release Test, a competent, intact, and level ice cover that extended from bank to bank and for a considerable distance upstream and downstream covered the Snake River. The flow from Willow Creek out onto the Snake River ice cover went through several stages. Initially, the water flowed out over the Snake River and inundated a wide area reaching past the center of the channel and for some distance up and downstream. The flow then apparently found (or created) several passages through the ice cover, and the inundated area was reduced in size. Eventually, the inundated area was reduced to an area located right at the mouth of the Out-flow Channel (Fig. 38). When the melt-out front reached the mouth, it melted out a relatively compact opening in the Snake River ice cover immediately at the mouth of Willow Creek. Following this, all the flow passed through this opening.

Figure 38. Willow Creek flow through Snake River ice cover, 12 February 2012 at 1630.

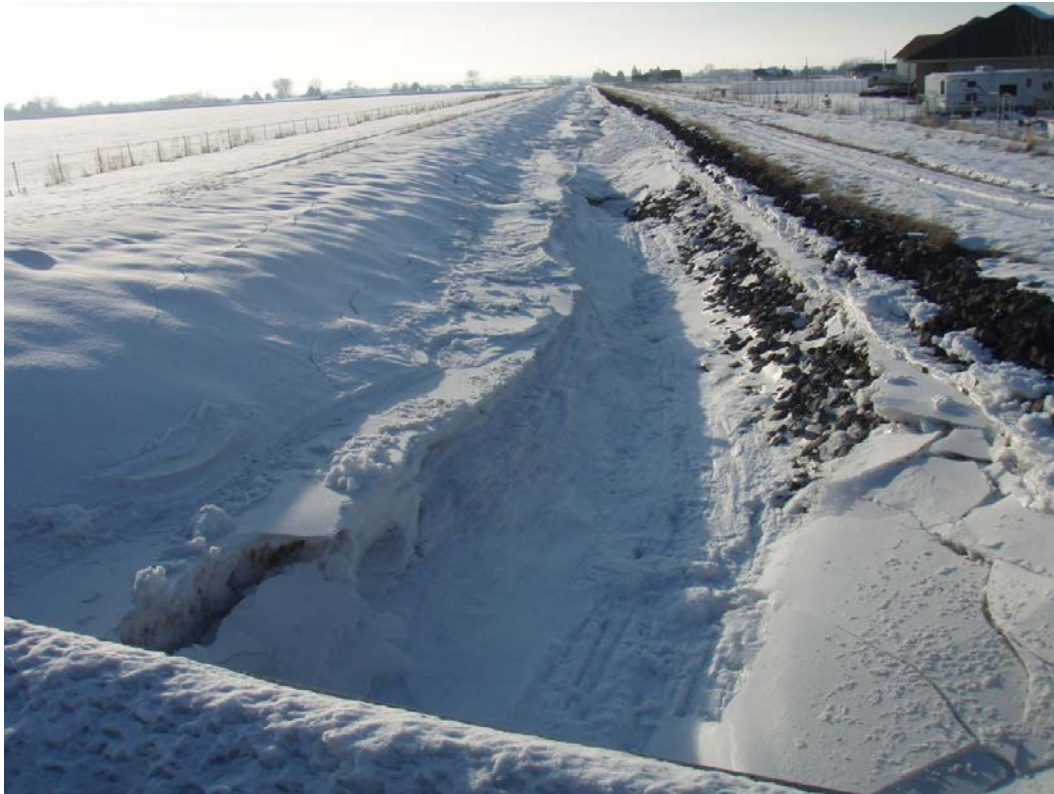
The major difference between 2011 and 2013 is probably the amount of snow in the channel prior to the releases. Unfortunately, there were no measurements of the snow conditions prior to the 2011 release. However, there are images of the snow remaining in the channel after the releases drained out in 2011 (Fig. 43) (Cooper 2013). These images show a relatively large blockage of snow following the release at the 25th St. Bridge.

Figure 43. Snow remaining in Floodway Channel at 25th St. Bridge following the release in 2011 (looking downstream). (Image by P. Cooper.)
